# **Commercialization of Technologies to Lower Defense Costs**

## **Final Demonstration/Validation Report For STAPP Bullet Catcher Evaluation at Fort A.P. Hill**

**March 2, 2006**

Report Number: NDCEE-CR-2006-001

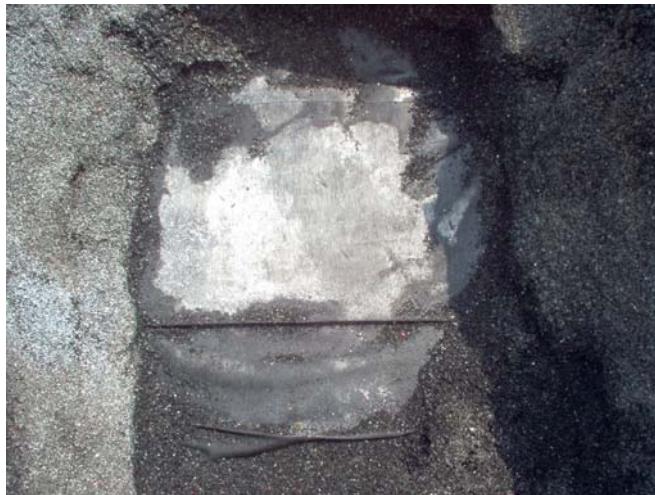
**Figure 48. Bottom Rubber Liner of Range 4, Lane 52.**

As sifting of the hot spot continued, it became obvious that the majority of the bullets were located in the top 6-8 inches of the granular rubber. Once the entire hot spot was sifted and the bottom rubber liner exposed, the liner was visually inspected for tears/holes. There were no visible tears/holes in the bottom rubber liner (please see Figure 48). Lane 52 hot spot sifting was complete at roughly 2:55pm.

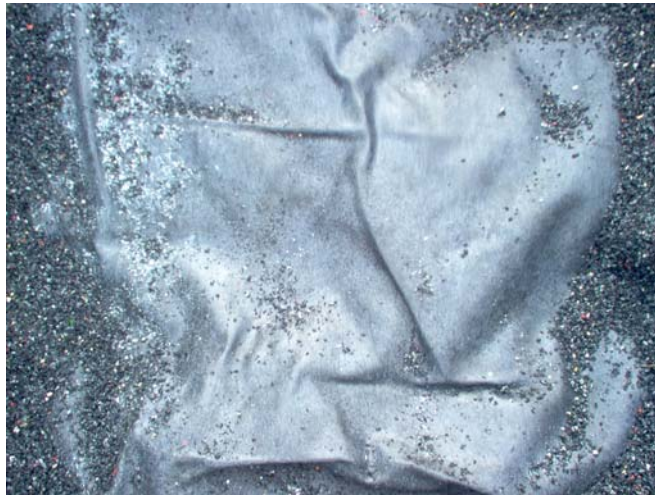
**Figure 49. Bottom Rubber Liner of Range 4, Lane 53.**

At 7:00am on 19 August 2004, Clean Harbors' 3-man crew was on-site and immediately began to continue sifting Lane 53. As with Lane 52, the majority of the bullets were concentrated in the top 6-8 inches of the granular rubber. Once the entire hot spot was sifted and the bottom rubber liner exposed, the liner was visually inspected for tears/holes. There were no visible tears/holes in the bottom rubber liner (please see Figure 49). Lane 53 hot spot sifting was complete at roughly 10:40am.

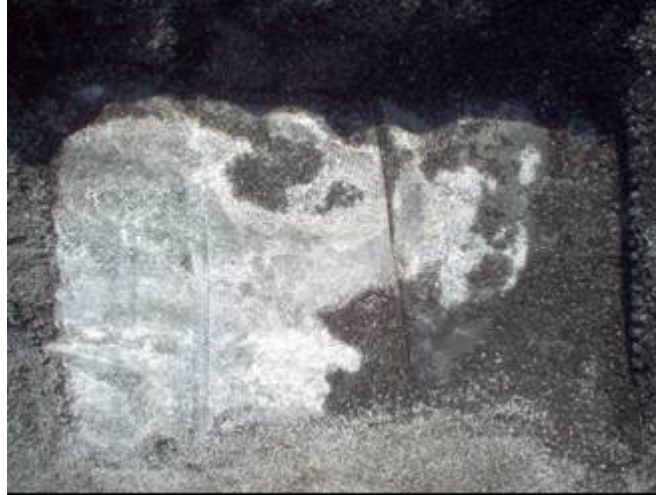
**Figure 51. Bottom Rubber Liner of Range 4, Lane 54.**

At approximately 11:00am Lane 54 sifting operations began. As with the other lanes the hot spot area was 70 inches x 50 inches and the bullets were also contained in the top 6-8 inches of granular rubber. The bottom rubber liner was visually inspected. No holes/tears were found (see Figure 51). Lane 54 sifting was complete at 4:15pm.

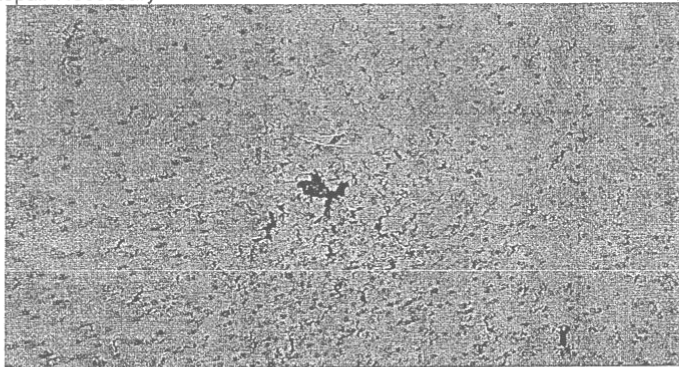
Damage is insignificant and local. Repair may soon be needed to prevent penetration of bullets up- and water down- through opening(s), and to protect against ricochets. CA-glue is recommended when mending.

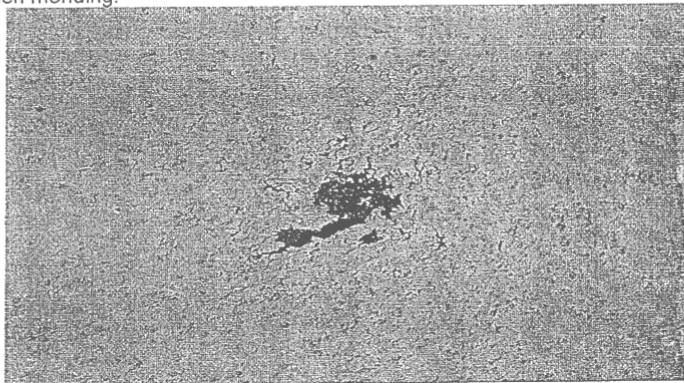
Bullet Catcher is saturated after intensive shooting with low-energy impact, large-bore rounds. Repair is imminent. It is recommended that upper rubber granules be replaced with new. Mend using CA-glue (alternative 1) or vulcanized-tape, (alternative 2).

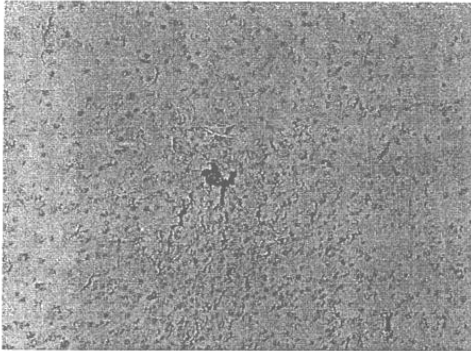
1. Example of wear damage which should be covered with a repair patch.
